PTPD REPORT NO. 83-R-02
AFPEA PROJECT NO. 82-P7-68

TEST AND EVALUATION OF METHOD II, GAU-8 30mm
AMMUNITION CONTAINERS

HQ AFALD/PTPD
AIR FORCE PACKAGING EVALUATION AGENCY
Wright-Patterson AFB OH 45433

August 1983

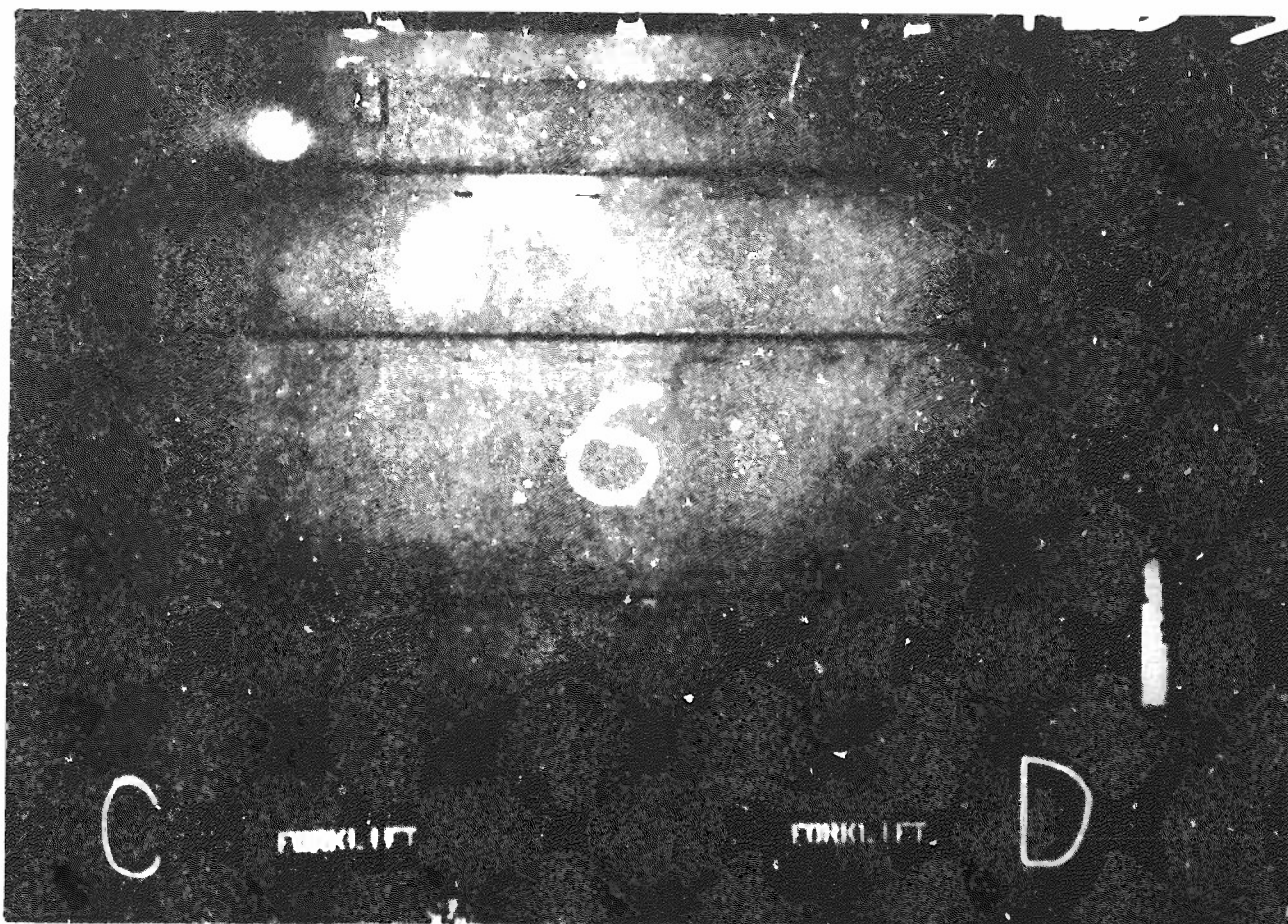
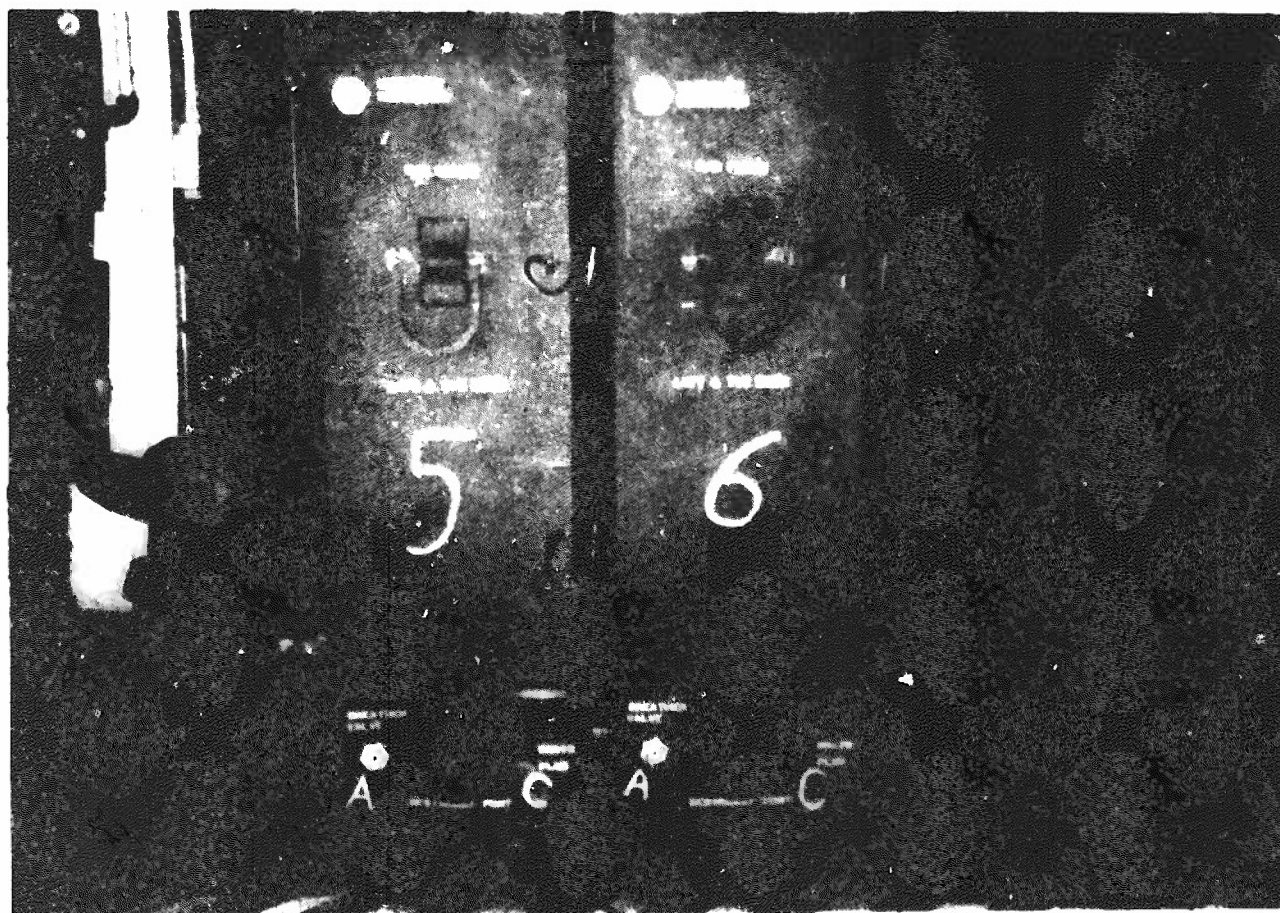
c. Comments: This test was performed out of the proposed test sequence at the manufacturer's request. Obvious deficiencies in the guard for the desiccant port cover and the breather valve existed. The manufacturer's representative had the necessary additional hardware to correct this problem with him but insisted on running the test prior to this modification. When the containers were impacted on the desiccant port ends, the desiccant port caps were crushed and would no longer seal. Also, on the final impact, which was to the broad side of one of the containers in the unit, small tears occurred in the sides of each container where the middle locking angle was welded. The locking pins were located in these middle locking angles. At this time, testing was terminated.

FIGURES 4 & 5. The first test unit.

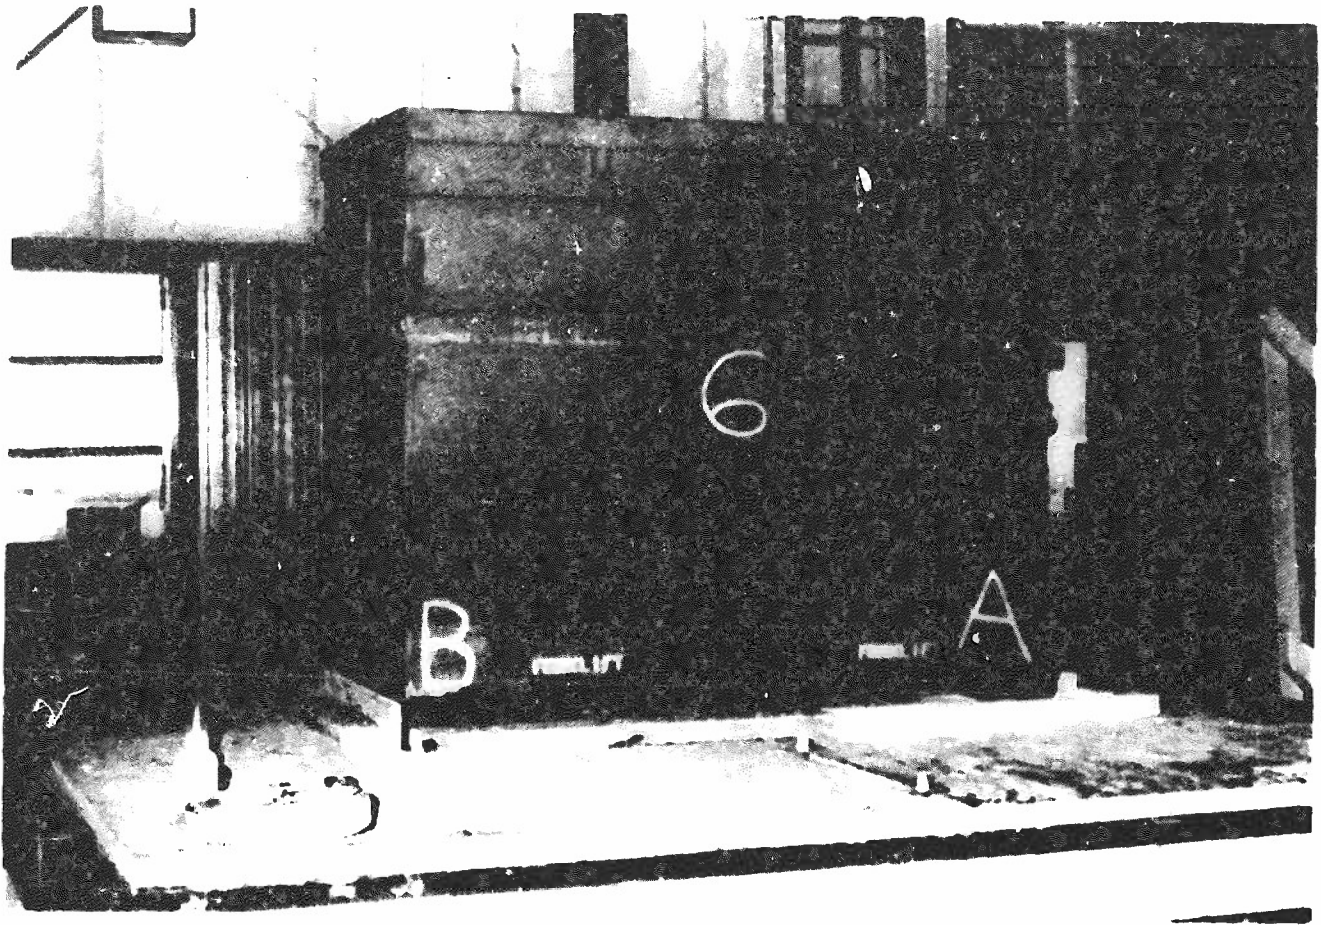
Comments: Although the vibration test was performed according to criteria listed in the test method, the attachment welds of the fork pocket to the container body were subjected to extremely severe loading forces which were excessive and not representative of the intent of the test. These excessive loads were generated primarily by the side to side rocking of the containers. However, since the containers were restrained at the bottom by a 2x4 fence (see Figure 8) and at the top by loose chains which prevented the containers from falling over and the input from the table was 1G, the test was completed.

FIGURE 8. Restraining system used for first vibration test. Chains (not shown) were also used to prevent container from falling over during the test.

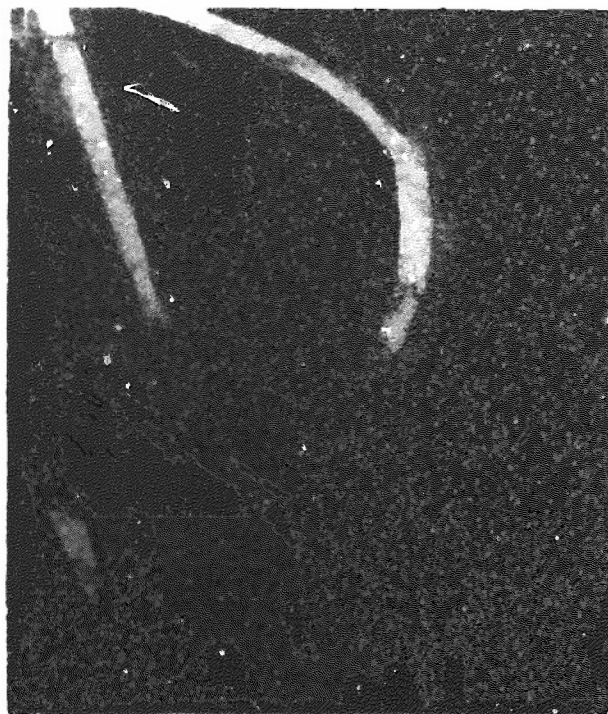
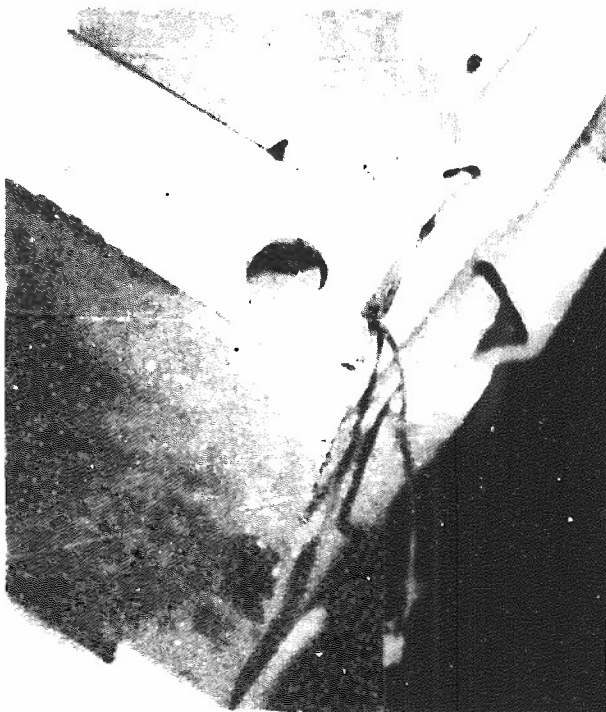
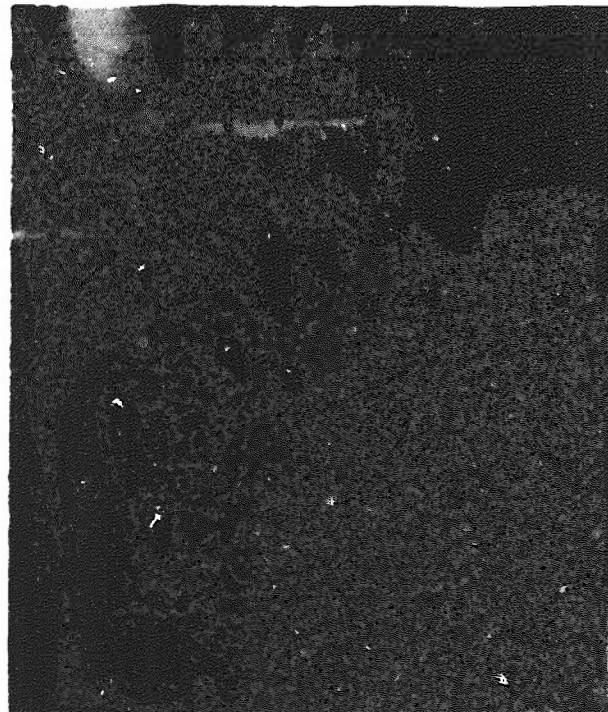
The end result was failure of the container skin material adjacent to the welds holding the fork pockets onto the containers (see Figures 9 & 10). Excessive wear to the pins and locking angles also occurred (see Figures 11 & 12). It should be noted that, after this vibration test was completed, a method providing a better restraining system that eliminated the rocking motion of the containers was developed. This method of further restraining the containers during testing was acceptable to all concerned (see Figure 13).

FIGURES 9, 10, 11 & 12. Damage to the containers during the first vibration test resulting in failure.

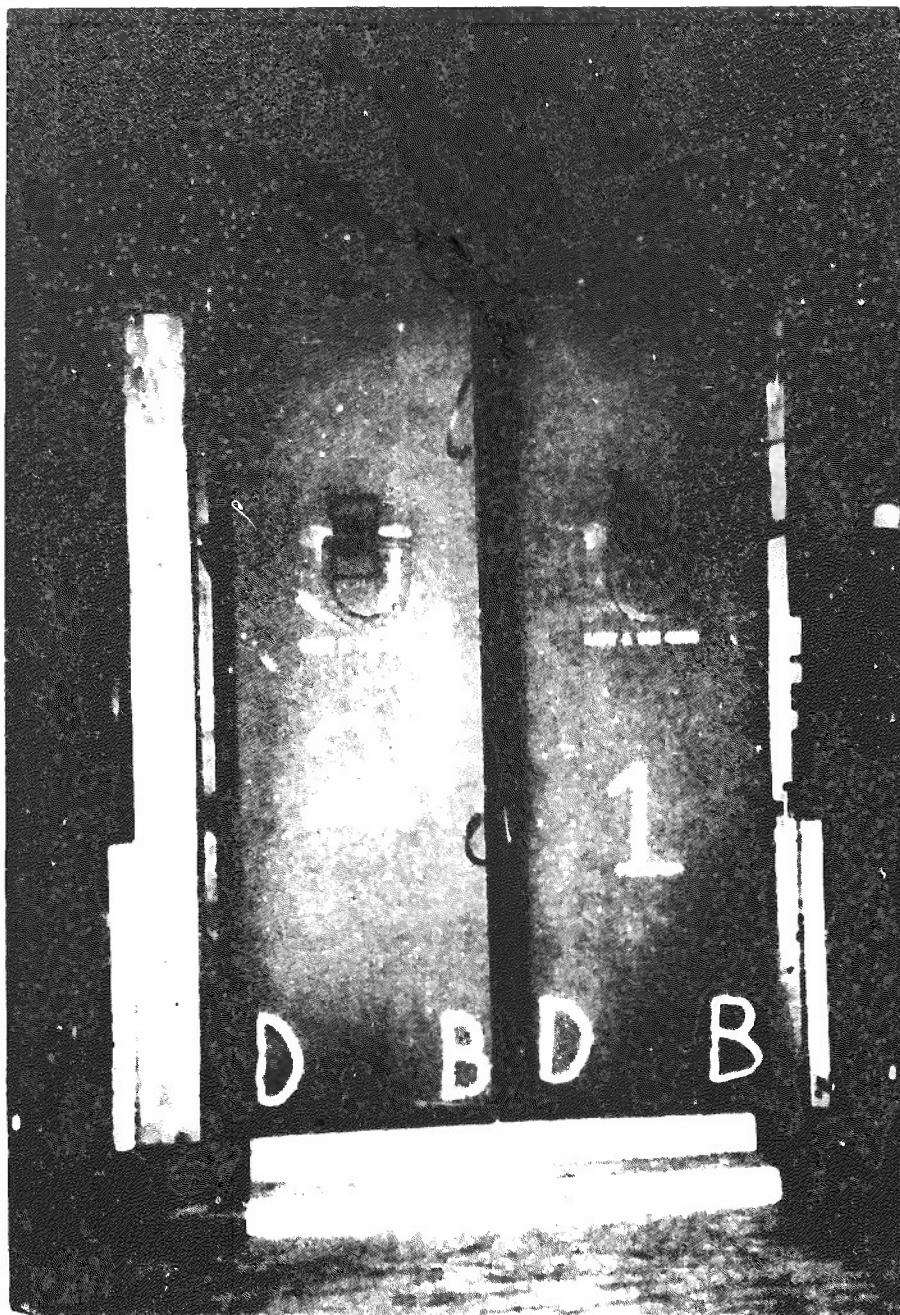
FIGURE 13. Improved restraint system for vibration test.

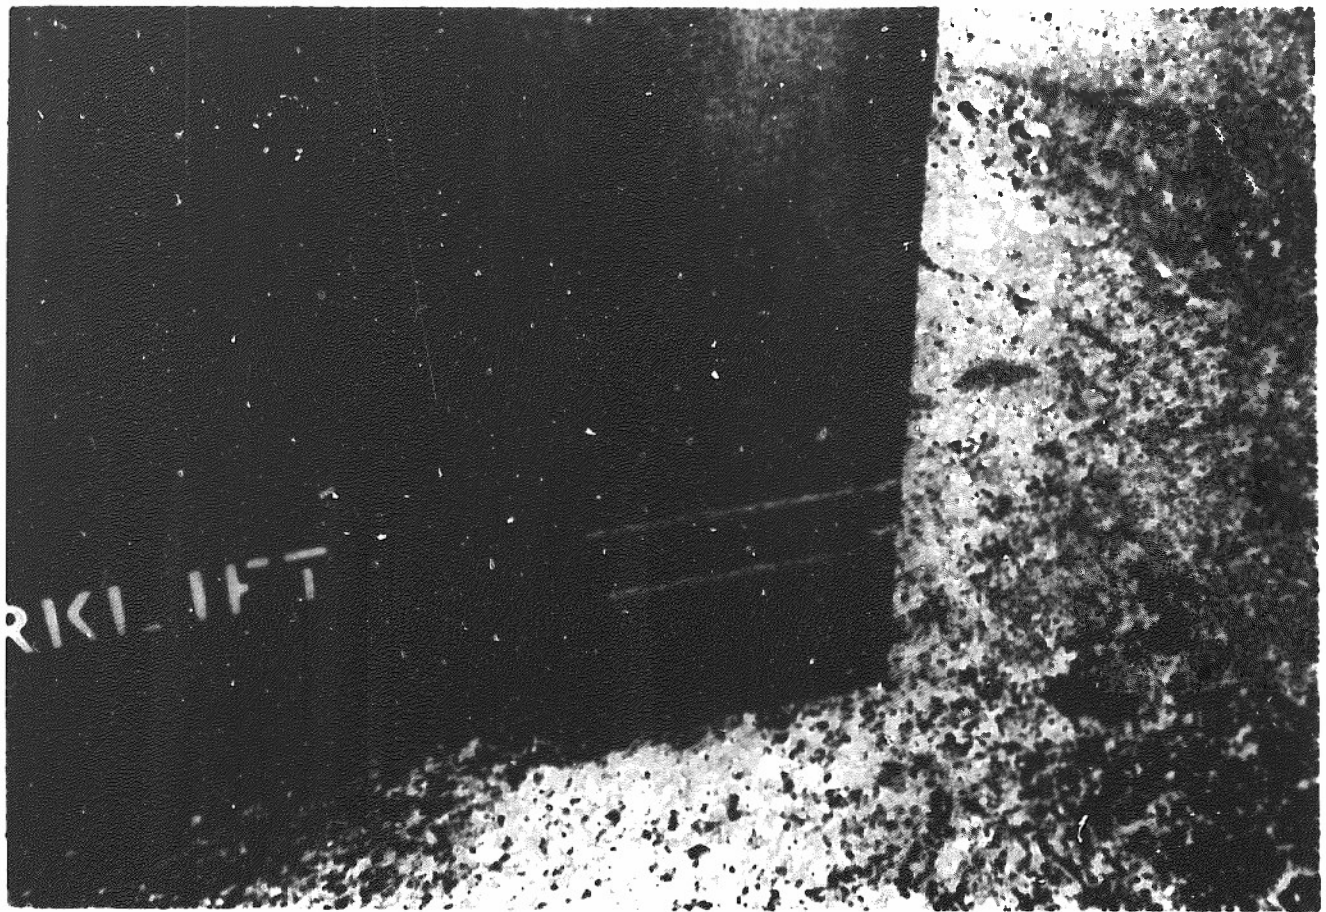
Preparations were made to load and use two of the remaining four containers and restart the testing sequence. The manufacturer's representative objected strongly to this approach, stating concern that the first modification which involved removing, changing, and then reattaching the forkwells had embrittled the container skin material during the second welding operation. Lanson offered to supply two new containers at no cost. This proposal was accepted. The two new modified containers arrived on Monday morning, 24 Jan 83. The modification consisted of welding the forkwell to these in angles (see Figure 14). These two containers, labeled TEST 1 and TEST 2, were loaded and prepared for testing. The test plan was altered from that previously used in two ways. Several of the tests were not repeated due to the results obtained in earlier testing. Also, the sequence was changed to reduce the significance of deformation from drop testing on the vibration test.

FIGURE 14. Modification used to prevent embrittlement of skin material from welding at point of forkwell attachment.

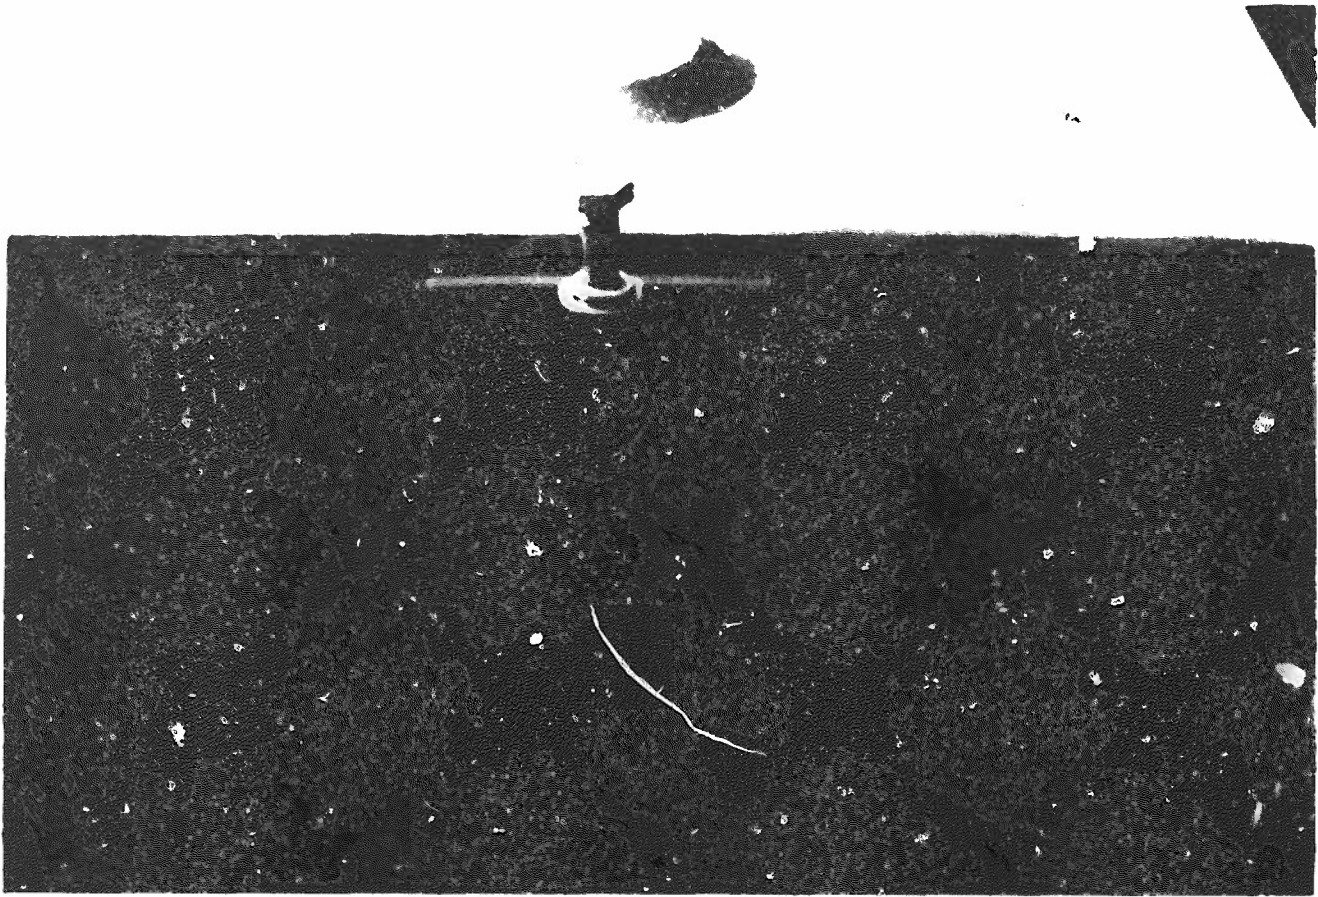
On 18 Apr 83, two additional containers were delivered to AFPEA. These containers incorporated modifications to correct the deficiencies previously identified. The problems with the desiccant port covers and the end fasteners on the lids were corrected. However, the problem with no clearance between the container lids when the containers were in their pinned configuration still existed. AFPEA had recommended a reduction in the container lid width of 1/4 inch. If this recommendation were followed, 1/16 inch to 1/8 inch clearance would exist between the container lids, allowing ease of operation. OO-ALC decided that a lid width reduction of 1/16 inch was all that was needed to provide the necessary clearance between the lids and would result in a "worst case" of a line to line fit. The two additional containers with the 1/16 inch lid width reduction are shown in Figures 21 & 22. As can be seen, negative clearance exists. The negative clearance is evident by the wear spots in the paint and metal where the lids touch and by the misalignment of the end fastener on one lid.

FIGURE 22. Misalignment of end bolt lid fastener on latest version of container received indicating no clearance between containers. Note the steel gussets welded to threaded bar and container side wall to reduce effect of bending moment on end bolt fasteners.

The width of the container lids should be reduced by the previously prescribed 1/4 inch to insure adequate clearance between containers. This change should definitely be incorporated into the design prior to delivery.
